Q3 与 Q7 系列托盘零位偏差大调节方法

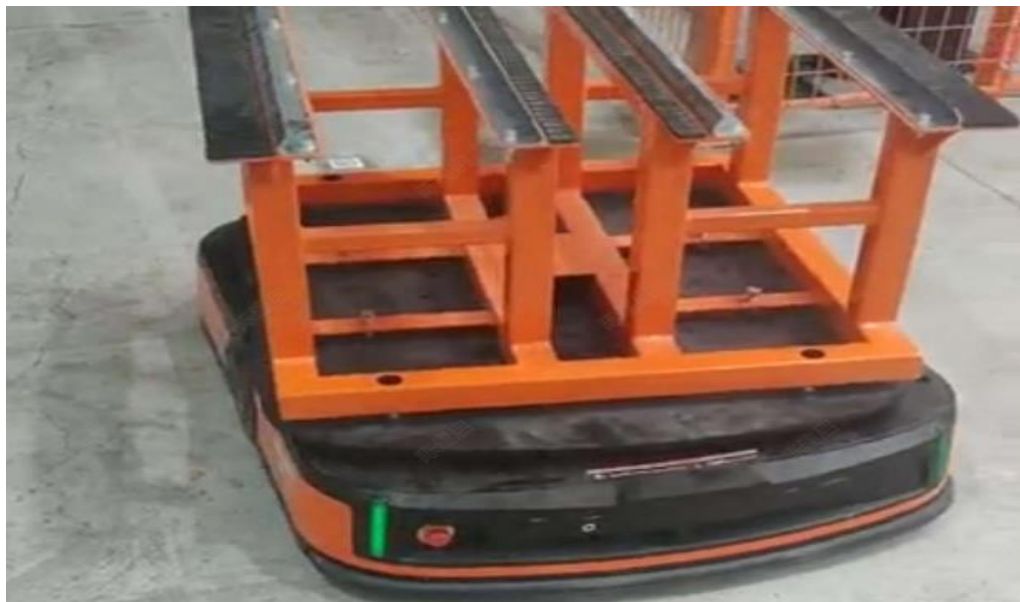
图 1

1, 问题描述：项目现场经常反馈 Q3 与 Q7X 开模车执行任务时托盘归零位结束后，举升托盘与 AGV 车体不平零位角度偏差大，无法对接精度要求高的机台，具体现场如图 1

2, 问题分析：排查硬件接触问题导致的零位异常，通过目测举升托盘与 AGV 车体不平行超出出厂规定角度，目测角度 15 度，现场使用 MRTTestTool_release(T1)标定工具进行标定，软件提示标定成功，但是问题现象没有任何改善，初步分析为出厂原始标定数据异常需清零重新写入。

3, 解决方法：使用 RCU 客户端版本为 2.8 版本，连接小车 ip，车辆连接成功后，在选项端选择串口以及客户端，通过软件选择 shell，输入 `get_rot param 1 0`, `get_rot param 2 0`，查看标定参数标准值，零位标定范围绝对值数值小于 5000 为合格，大于 5000 需要清零重新标定，标定数据清零命令为 `set_rot param 4 0`, 数值清零后，清零后敲 `set_rot param 3 0` 为保存命令，具体步骤如图 2，图 3，标定清零后使用 T1 标定工具对 AGV 零位进行重新标点，标定步骤按照图 4，图 5，图 6，图 7，标定显示成功后请保存数据。
